TYPE B ACCIDENT INVESTIGATION BOARD REPORT OF THE DECEMBER 15, 1997, LEAKAGE OF WASTE CONTAINERS NEAR KINGMAN, ARIZONA

U.S. Department of Energy
Fernald Environmental Management Project

Type B Accident Investigation Board Report of the December 15, 1997 Leakage of Waste Containers Near Kingman, Arizona

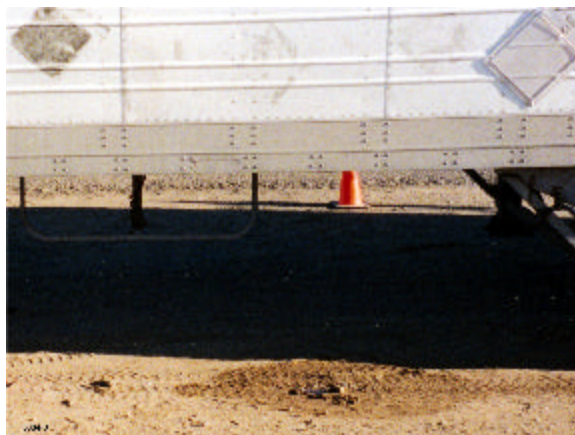
The event occurred as a shipment of seven White Metal Boxes containing low level radioactive waste was en route from FEMP to NTS. The truck driver identified the leakage of an unknown liquid from his trailer as he was preparing for a routine stop near Kingman, Arizona. There had been no observable leak at his previous inspection stop, approximately 370 miles before. He parked the truck adjacent to the Petro Truck Stop at Exit 66 of Interstate Highway 40 and notified FDF at 1654 Eastern Standard Time.⁴

Figure 2-1 The Leaking Trailer

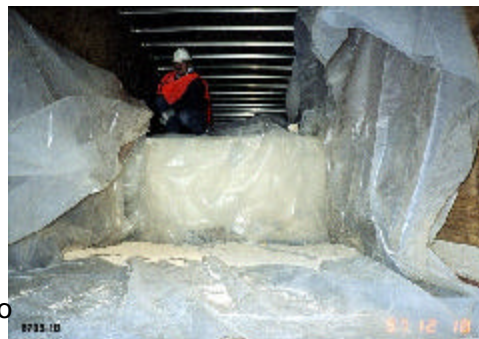
Figure 2-2 Leaking Containers Within a Plastic Overwrap

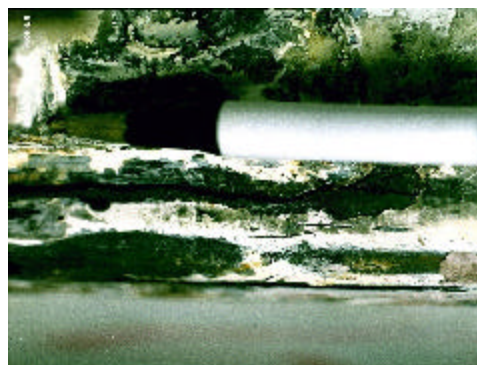
After unloading the waste, samples of both of the failed areas of container 483141 were removed. One was sent to the manufacturer for analysis. Later, the Board had the other failed area of 483141 sent to Sandia National Laboratories/New Mexico for independent analysis. The results from the analysis of the sample of 483141 provided to Sandia National Laboratories/New Mexico are discussed below. The results of the manufacturer's analysis of the other sample were unavailable in time to be evaluated by the Board.

Figure 2-5 One of the Cracked Areas on Container 483141

- ! The preponderance of evidence indicates that the primary crack resulted from combined bending and shear stresses that exceeded the yield and ultimate strength of the material, resulting in ductile overload failure.

- ! Stress corrosion crack growth occurred subsequent to initial crack formation. This growth may have occurred during storage, transport, or both.
- ! The vibrations and cyclic loads experienced during transportation caused the mating crack surfaces to repeatedly rub over one another, resulting in wear and the effective widening of the crack to the point where leakage occurred.

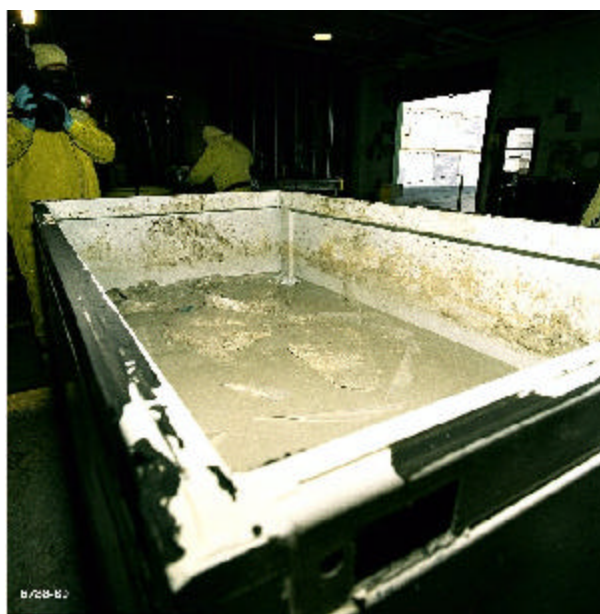
A calculation was performed to determine whether the free liquid present in Number 483004 exceeded the NTS Waste Acceptance Criteria of 1% free liquid. Using the assumption that the density of the liquid was that of water and neglecting the possible loss of Dicalite for conservatism, the 207 pound weight loss equated to 24.9 gallons. The NTS criterion for this waste volume under these assumptions is approximately 7 gallons. In addition, observation of the contents of 483004 after opening revealed more free liquid than would be allowed by the NTS requirement remained in the container on top of the waste, even after the loss of 207 pounds.

Figure 2-3 Box 483004 After Return to the FEMP

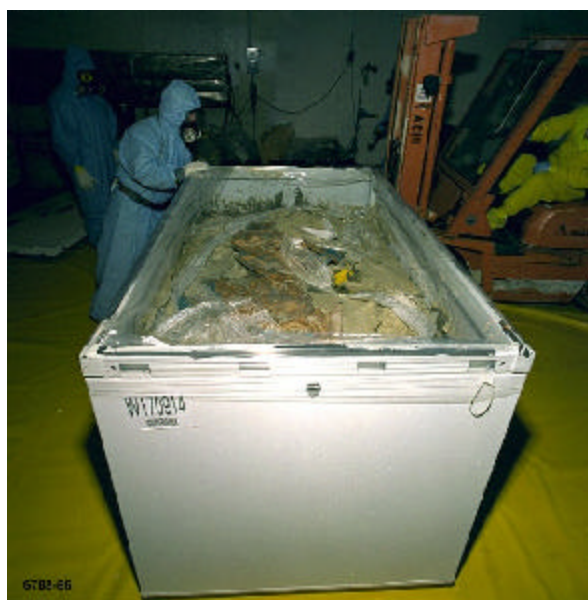
Figure 2-4 Box 483141 After Return to the FEMP

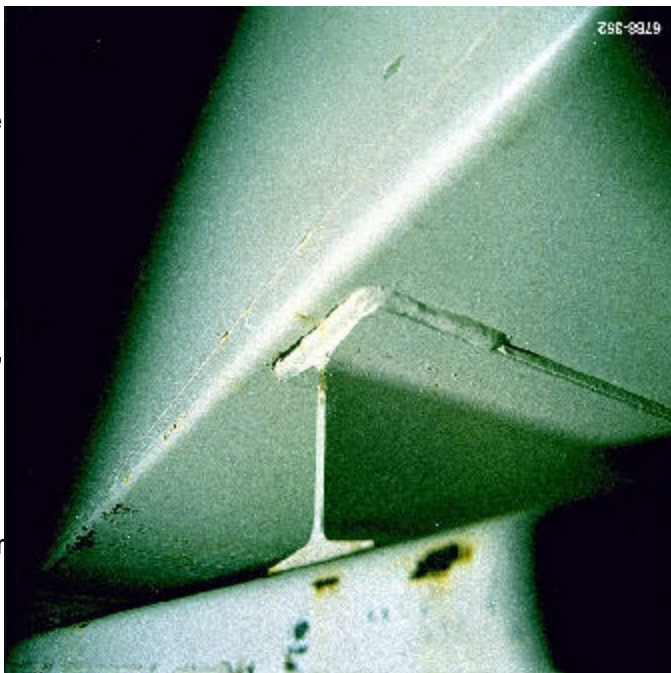
Figure 2-6 Loaded Container Showing Indications of Paint Cracking

The Board examined a number of containers stacked and awaiting shipment at FEMP. Loaded waste containers stacked in Plant 6 were examined. These containers contain uranium materials awaiting shipment to British Nuclear Fuels, Limited. Many of these exhibited cracking and spalling of paint and inward displacement of the base plate at the end of the center runner. In addition, a number of loaded waste containers awaiting shipment to NTS were examined in Building 30A. Paint cracking and rust was visible in approximately 1/3 of these containers at the ends of the center runner. A typical observation is shown in Figure 2-6.

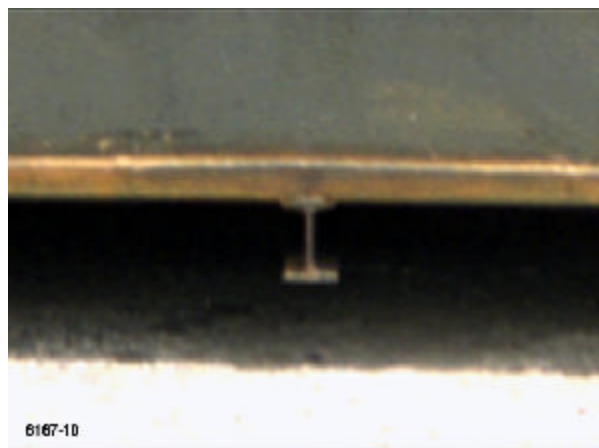
Figure 2-7 The Metal Container Tested

The evaluation included performing the required tests against sample containers supplied by CGR Compacting, Inc. (CGR). (CGR was the lowest qualified bidder). The sample containers successfully completed all the required tests. CGR noted that 11 gauge steel was required to pass the specific vibration test, rather than the minimum of 12 gauge steel required by the Request For Proposal. Pictures taken during the testing of the CGR samples show the runners flush with the side walls of the container (See Figures 2-7 and 2-8).

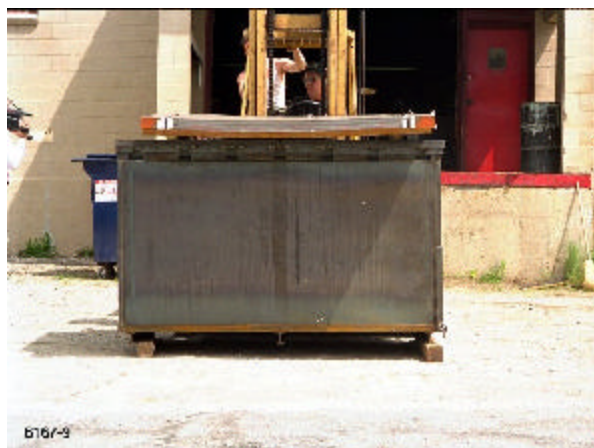
Figure 2-8 Closeup of the Center Runner Area on the Metal Container Tested
